AK Home Inspection Services LLC

Home Inspection Report

14012 E River Bend Cir

Inspected on Mon, Jun 24 2024 at 10:00AM

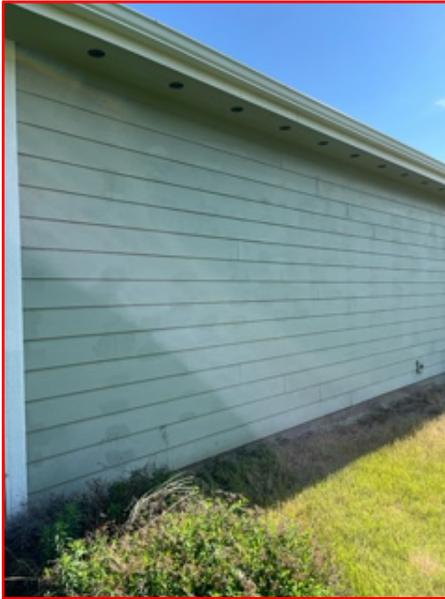
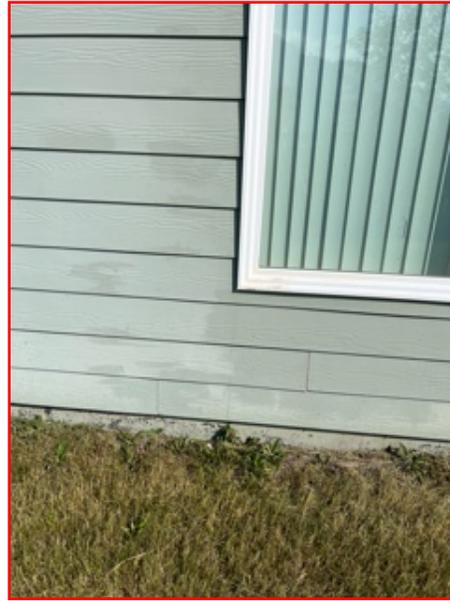
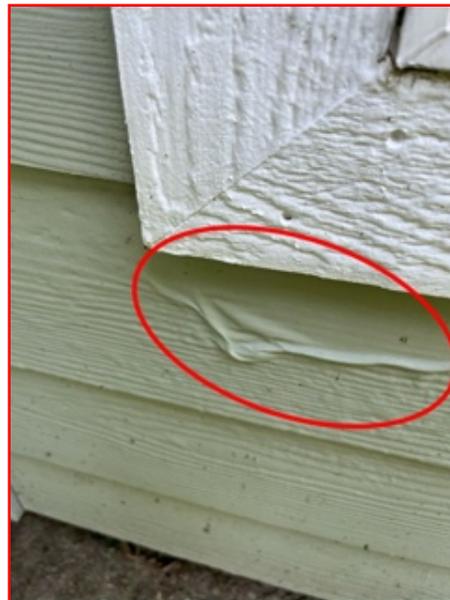
Paint wearing/thin spots on the southern back side of the house. Recommend sanding and painting the exterior of the house to extend the life of the siding.

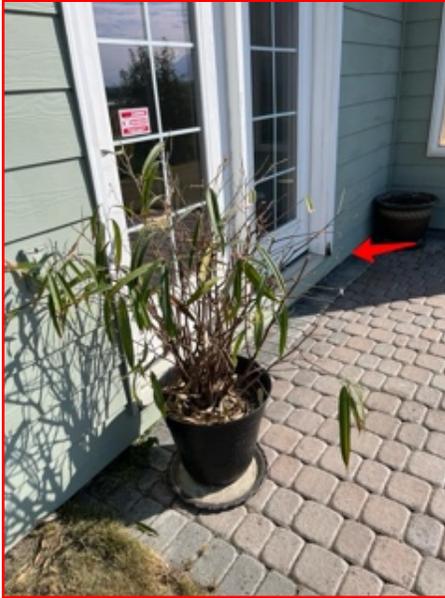
Figure 2-1

Back exterior door jamb has water damage at the bottom of the door jam possibly from snow melt water runoff. Recommend a qualified contractor assess and see if the jam needs to be replaced or just sanded and painted.

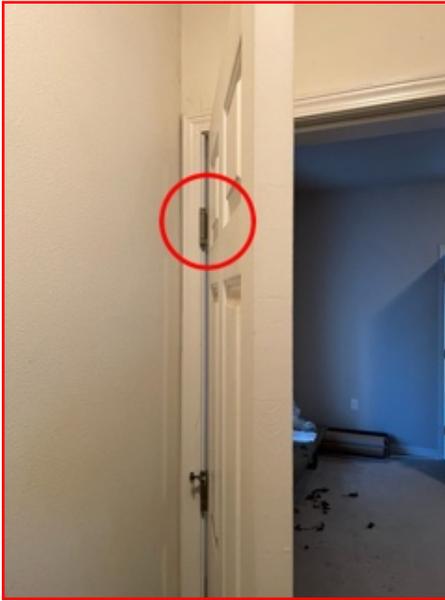
Figure 3-1

Both garage entry doors into living areas are fire safety doors. They have to close and latch on their own and make an air tight seal. Recommend a qualified contractor adjust or replace the spring hinges to allow the doors to close and latch on their own and new gaskets if necessary to seal properly.

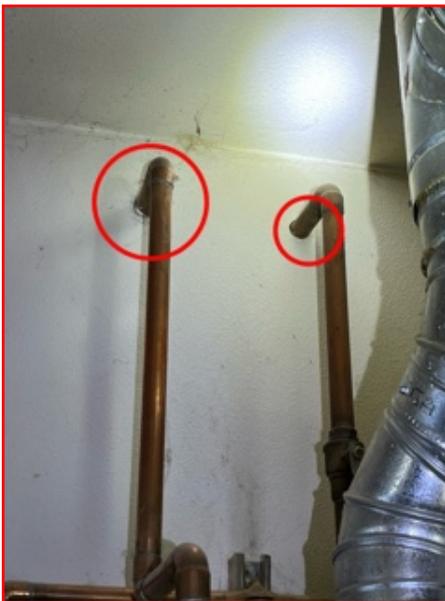
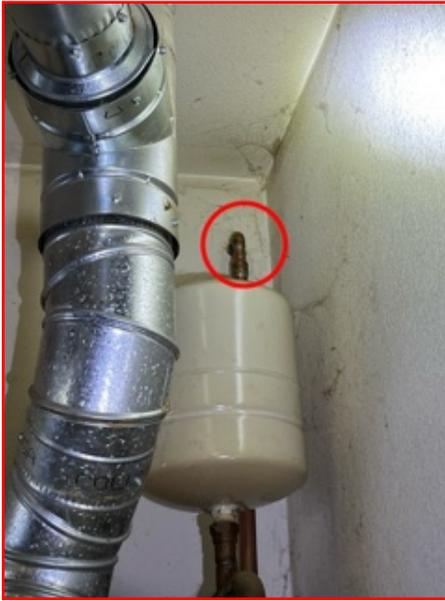
Multiple penetrations through the Sheetrock in the garage are not fire caulked. All penetrations through Sheetrock from garage need to be fire caulked to keep fumes from entering the home. Recommend fire caulking all penetrations through the ceiling and walls in the garage.

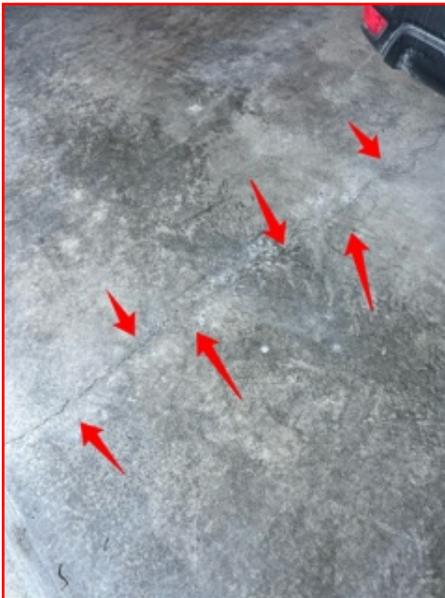
Figure 5-1

It was observed that there are cracks (1/16"-1/8") in the garage concrete slab. Recommend a qualified contractor assess and seal with epoxy to fill, strengthen, and waterproof the slab.

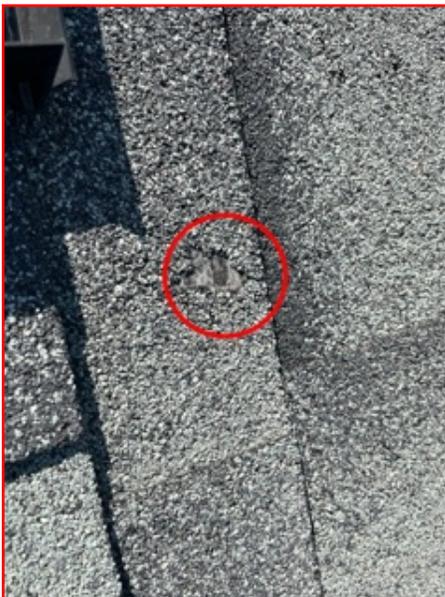
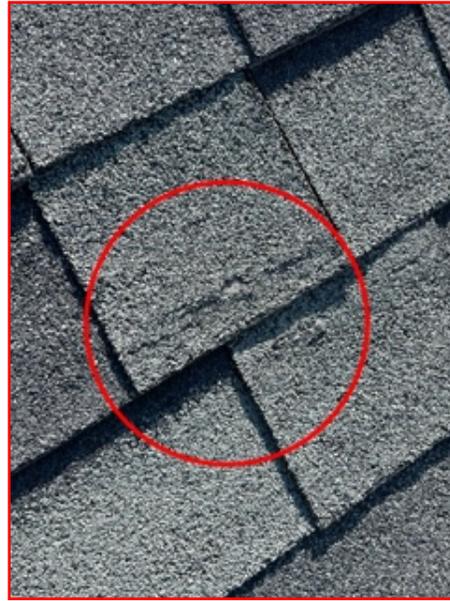
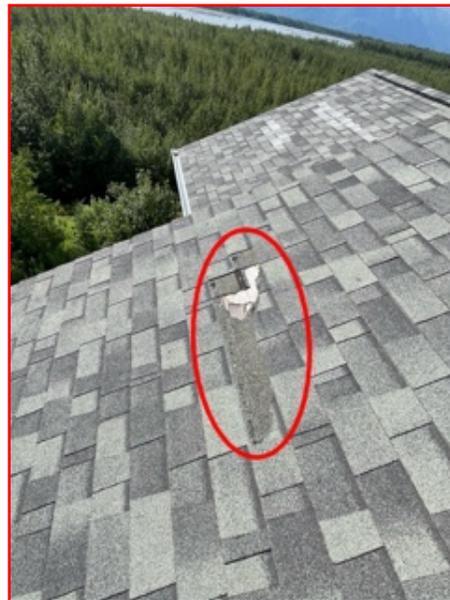
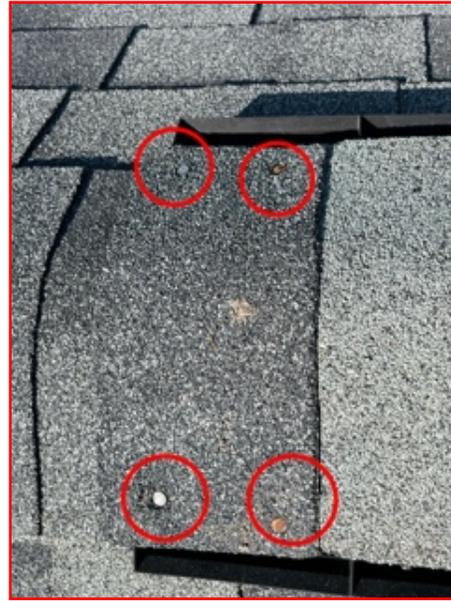
Several missing shingles, exposed wood sheathing, a few torn shingles to fiberglass layer, and rusted nail heads visible. Roof is believed to be the original roof (16 yrs old). Recommend a qualified roofing contractor assess and fix/repair missing shingles, torn shingles and epoxy nail hairs to weatherproof.

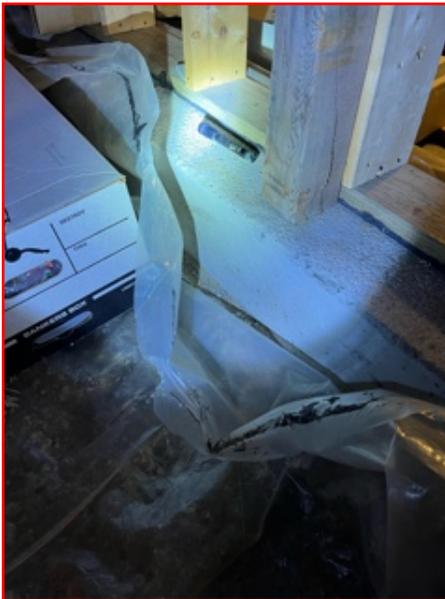
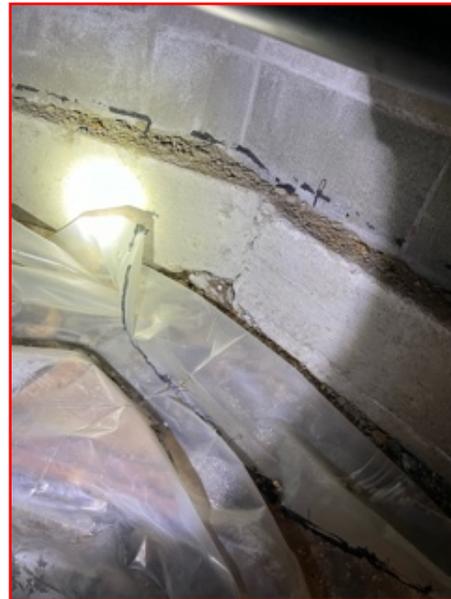
Vapor retarder is in place, but starting to come away from the acoustic caulking on some spots on the concrete footer. Recommend having a contractor re-seal the vapor barrier to the walls and footer properly with acoustic caulking.

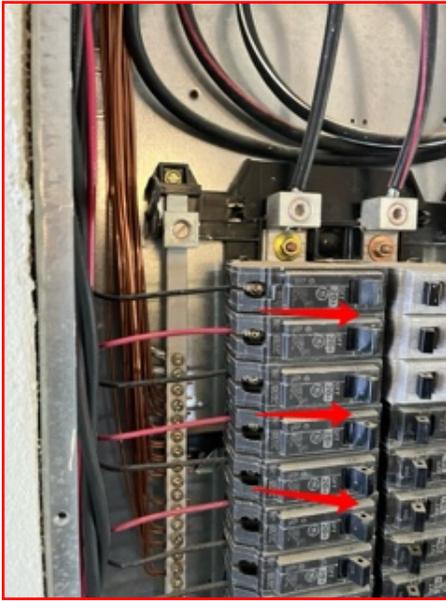
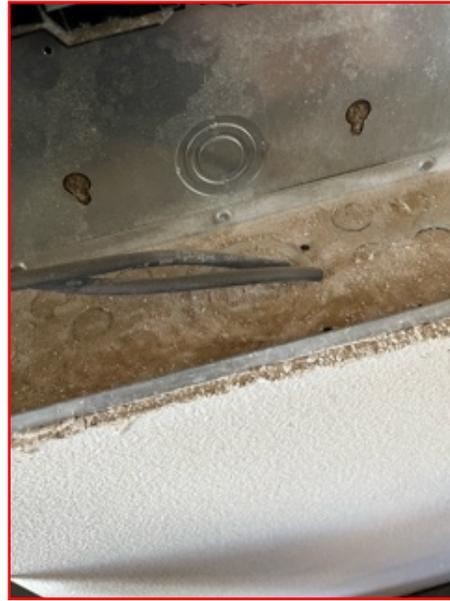
The distribution service panel in the garage has possible multi branch wiring. Also, 2 large (6 gauge) wires exposed in the box. Recommend a qualified electrician assess and fix/repair with handle tying the breakers so one can't trip without the other or install black tape on the red wires to signal a 120 conductor and terminate large gauge wires with wire nuts.

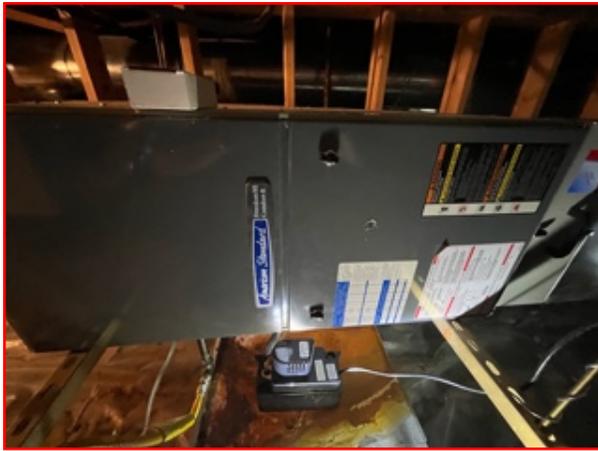
Figure 10-1

No recent records of service for furnace, water heater, or garage unit heater. Also, found rust in the burner area. Recommend a qualified contractor to service, clean, and inspect furnace, water heater, and garage unit heater with filter replacement on the furnace.

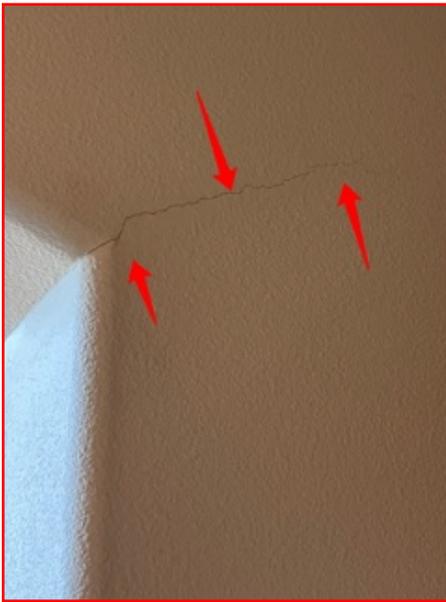
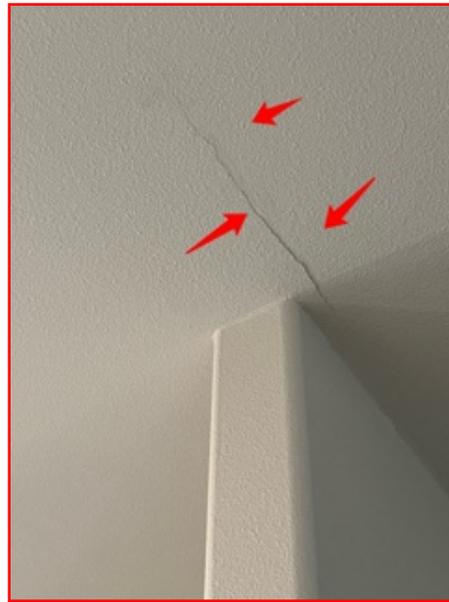
It was observed that there was some foundational movement that occurred with horizontal, vertical, and diagonal cracking above doors and windows. Windows and doors still open and close so, it appears to be mostly superficial Sheetrock cracking. Recommend a qualified contractor assess and fix/repair Sheetrock.

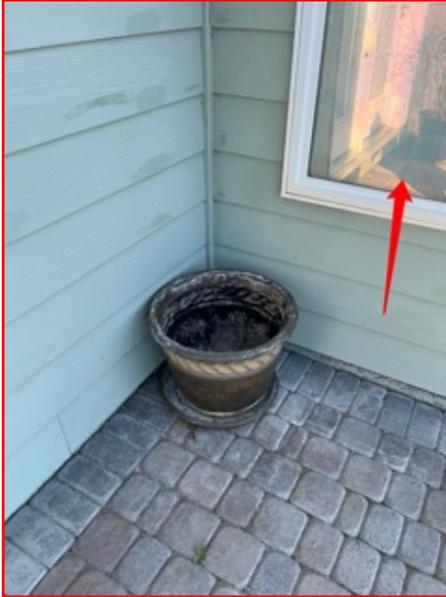
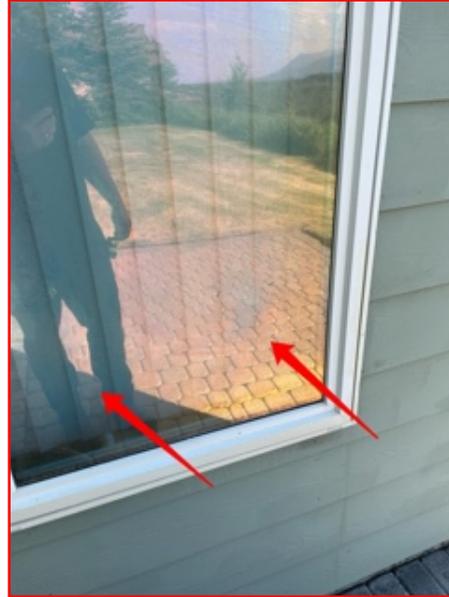
Living room window is fogged and the seal has broken letting moisture in between the panels of glass. Recommend a qualified contractor fix/repair or replace the window.

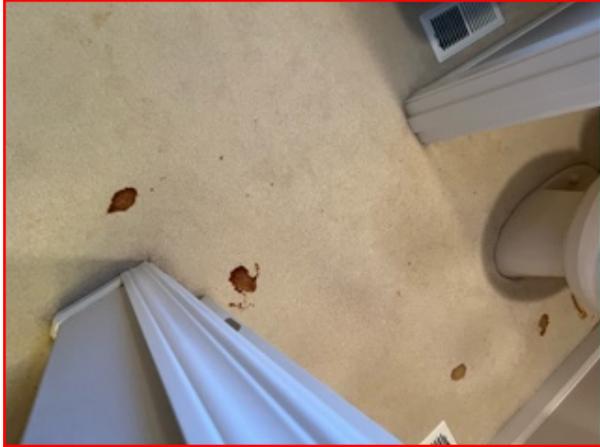
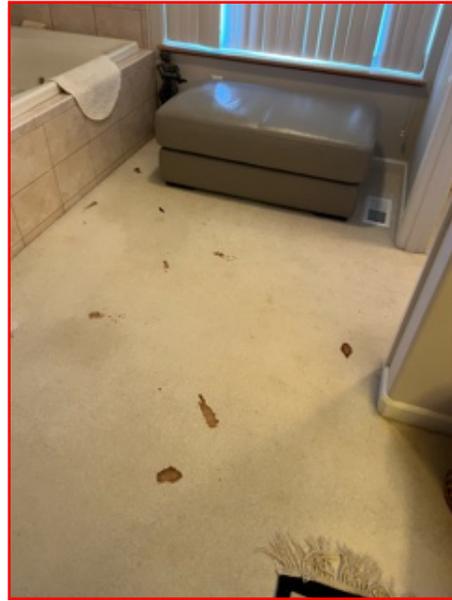
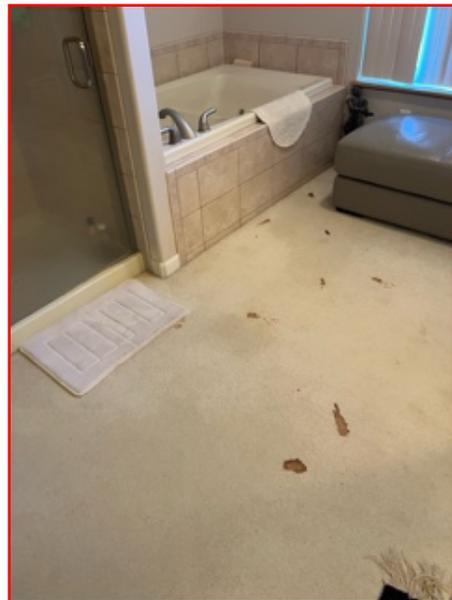
Carpet in upstairs bedroom stained (pet remains). Recommend a qualified contractor assess and replace carpet.

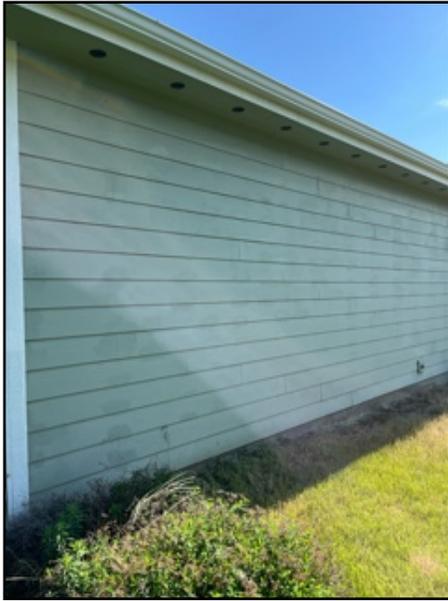
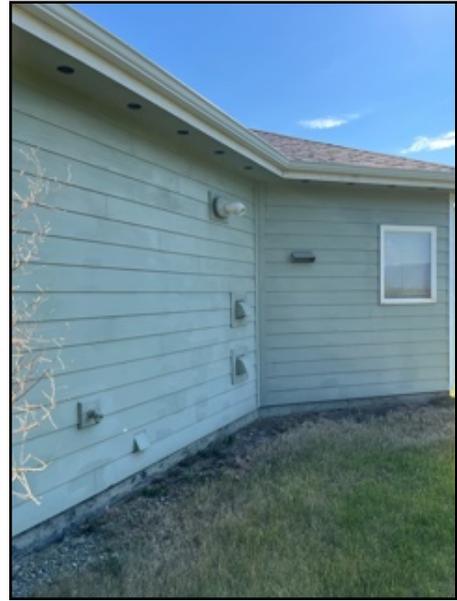
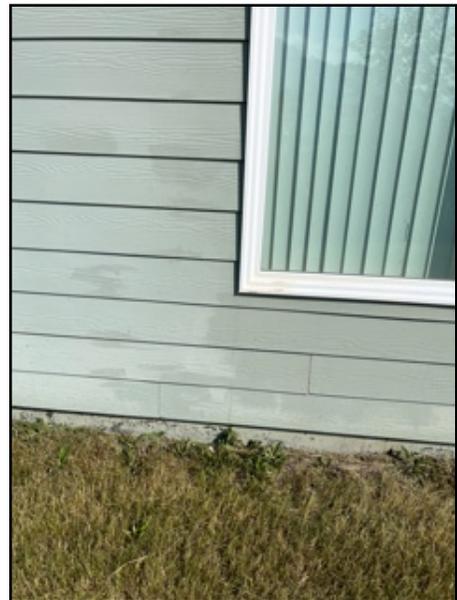
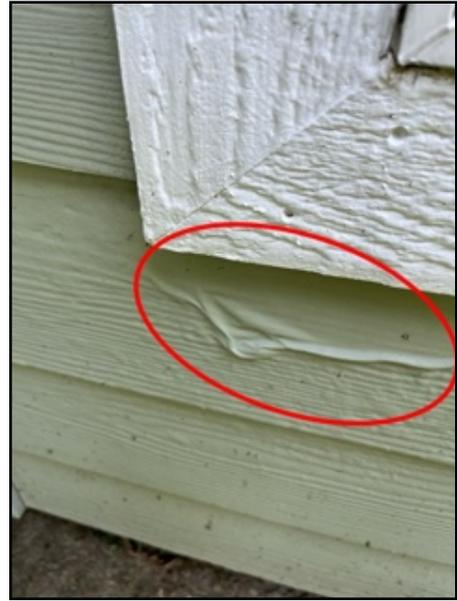
Paint wearing/thin spots on the southern back side of the house. Recommend sanding and painting the exterior of the house to extend the life of the siding.

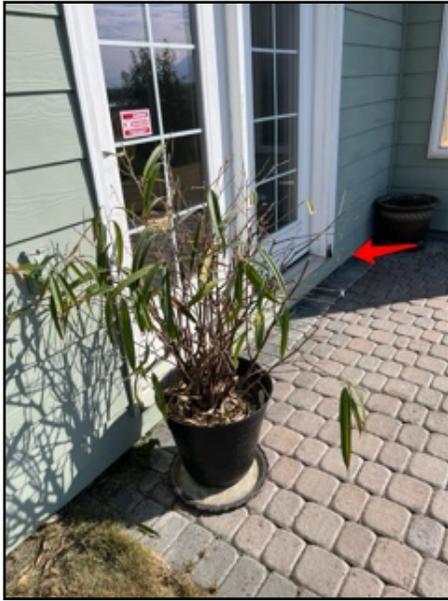
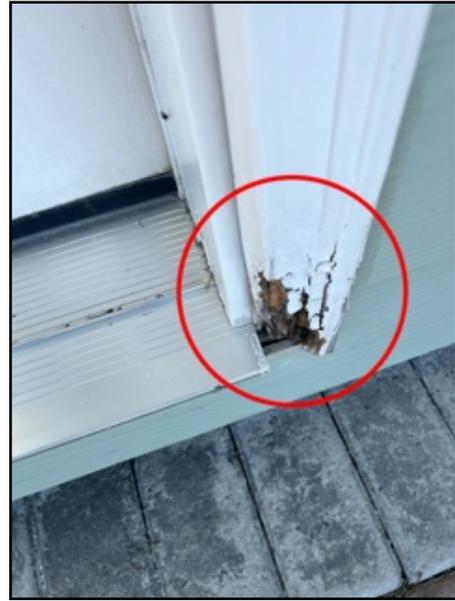
Back exterior door jamb has water damage at the bottom of the door jamb possibly from snow melt water runoff. Recommend a qualified contractor assess and see if the jamb needs to be replaced or just sanded and painted.

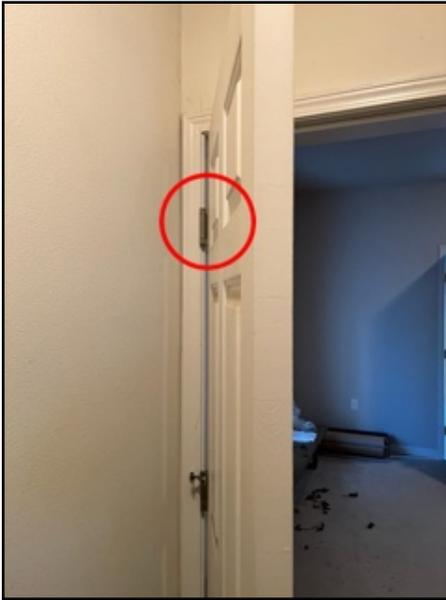
Figure 3-1

Both garage entry doors into living areas are fire safety doors. They have to close and latch on their own and make an air tight seal. Recommend a qualified contractor adjust or replace the spring hinges to allow the doors to close and latch on their own and new gaskets if necessary to seal properly.

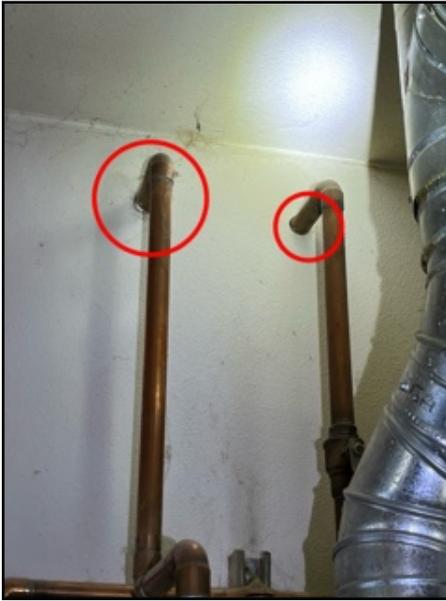
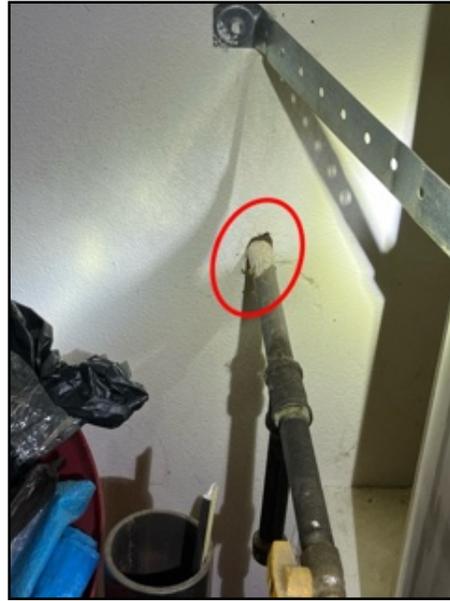
Multiple penetrations through the Sheetrock in the garage are not fire caulked. All penetrations through Sheetrock from garage need to be fire caulked to keep fumes from entering the home. Recommend fire caulking all penetrations through the ceiling and walls in the garage.

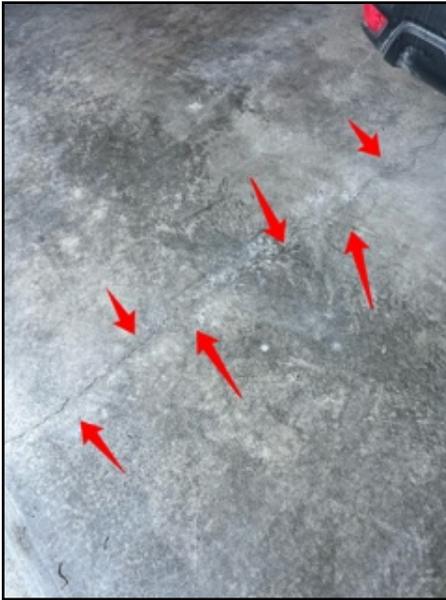
Figure 5-1

It was observed that there are cracks (1/16"-1/8") in the garage concrete slab. Recommend a qualified contractor assess and seal with epoxy to fill, strengthen, and waterproof the slab.

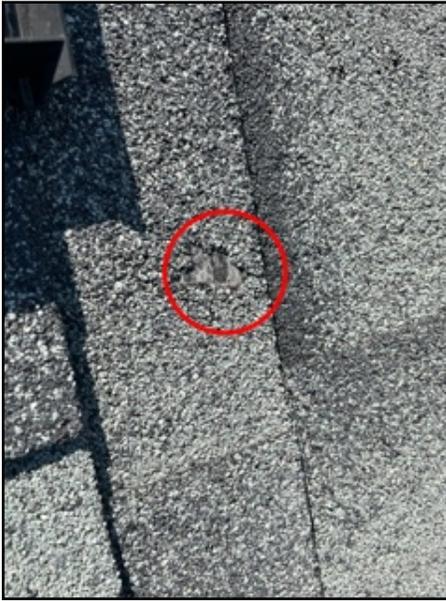
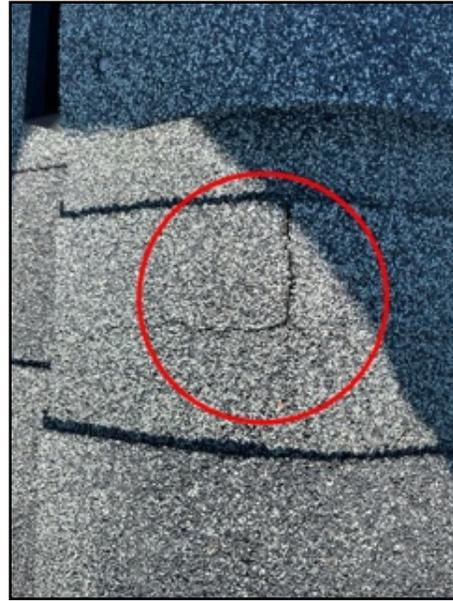
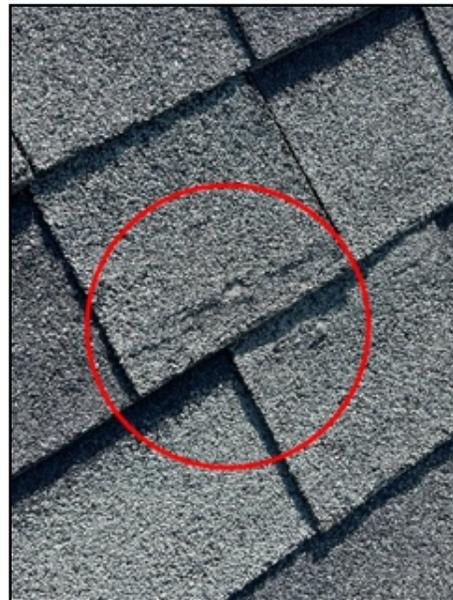
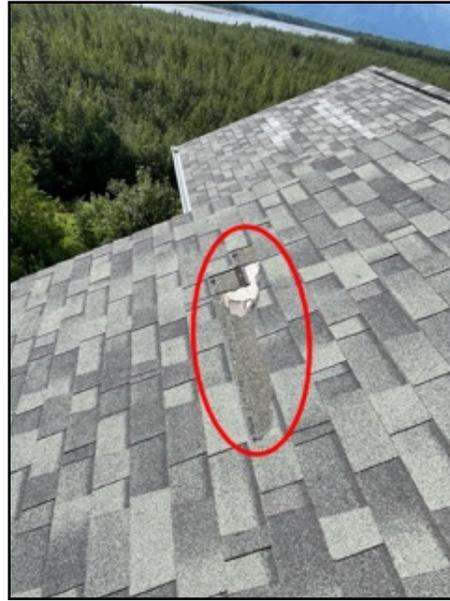
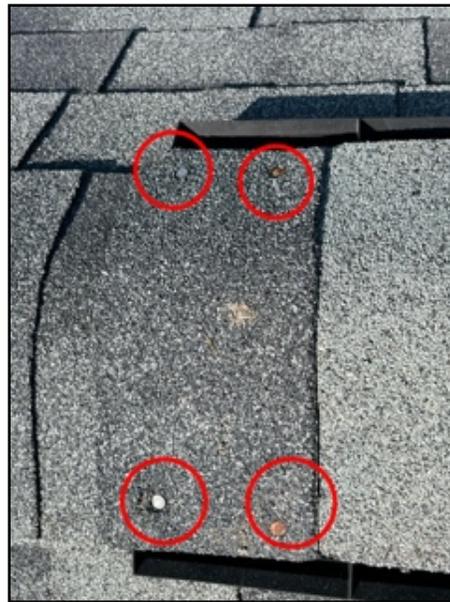
Several missing shingles, exposed wood sheathing, a few torn shingles to fiberglass layer, and rusted nail heads visible. Roof is believed to be the original roof (16 yrs old). Recommend a qualified roofing contractor assess and fix/repair missing shingles, torn shingles and epoxy nail hairs to weatherproof.

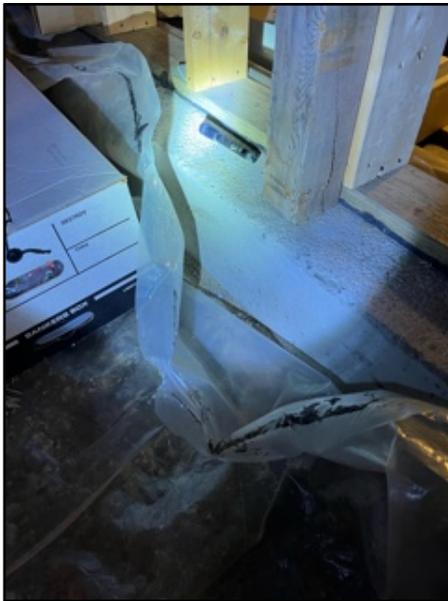
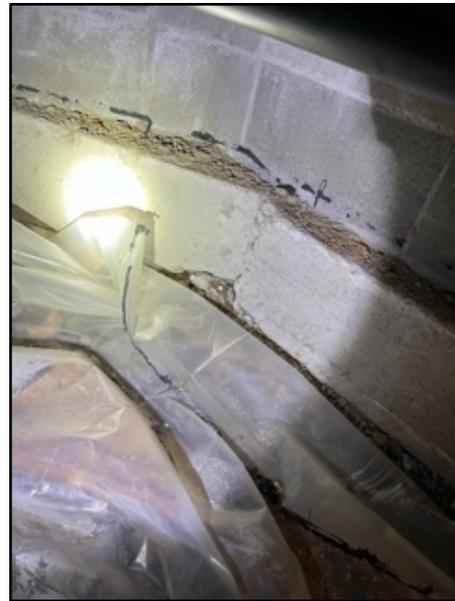
Vapor retarder is in place, but starting to come away from the acoustic caulking on some spots on the concrete footer. Recommend having a contractor re-seal the vapor barrier to the walls and footer properly with acoustic caulking.

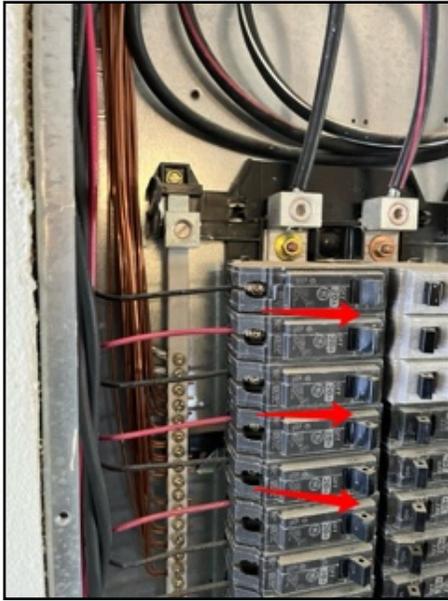
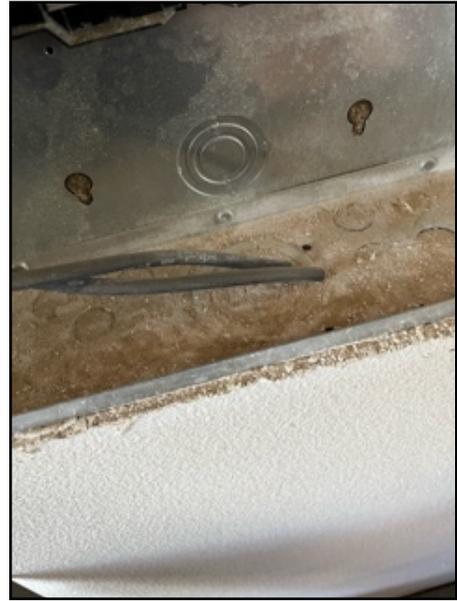
The distribution service panel in the garage has possible multi branch wiring. Also, 2 large (6 gauge) wires exposed in the box. Recommend a qualified electrician assess and fix/repair with handle tying the breakers so one can't trip without the other or install black tape on the red wires to signal a 120 conductor and terminate large gauge wires with wire nuts.

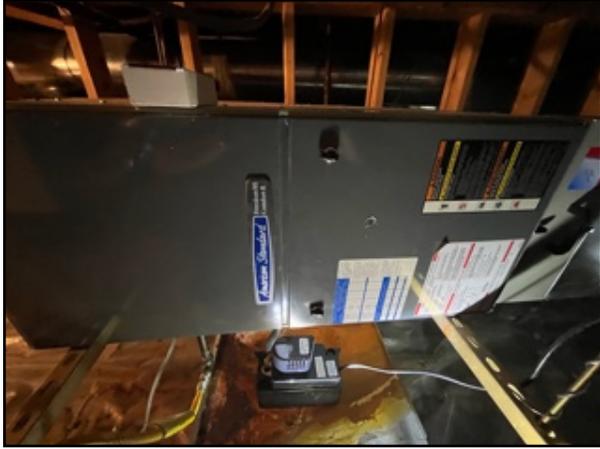
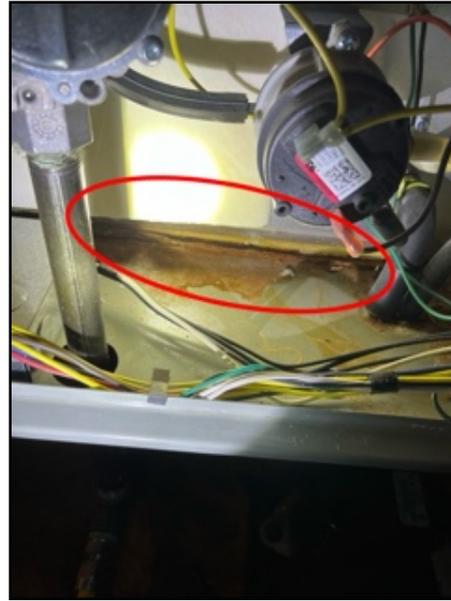
No recent records of service for furnace, water heater, or garage unit heater. Also, found rust in the burner area. Recommend a qualified contractor to service, clean, and inspect furnace, water heater, and garage unit heater with filter replacement on the furnace.

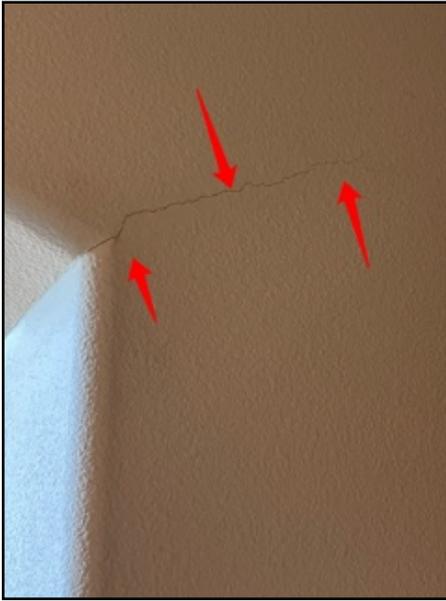
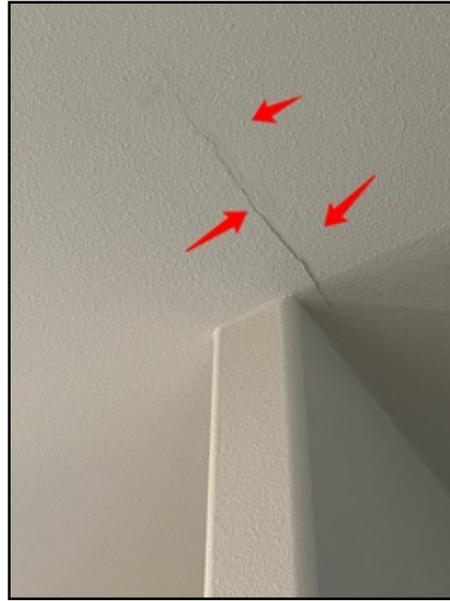
It was observed that there was some foundational movement that occurred with horizontal, vertical, and diagonal cracking above doors and windows. Windows and doors still open and close so, it appears to be mostly superficial Sheetrock cracking. Recommend a qualified contractor assess and fix/repair Sheetrock.

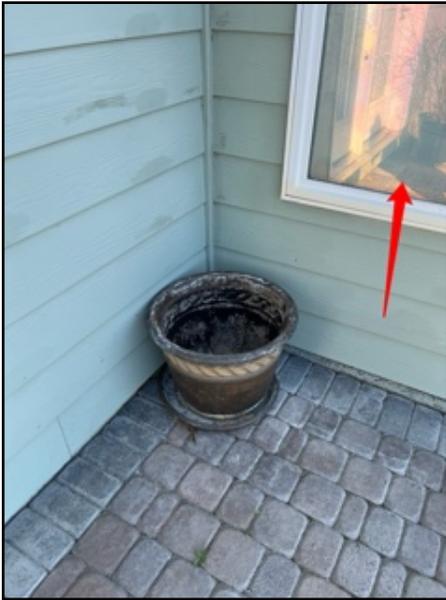
Figure 13-1

Living room window is fogged and the seal has broken letting moisture in between the panels of glass. Recommend a qualified contractor fix/repair or replace the window.

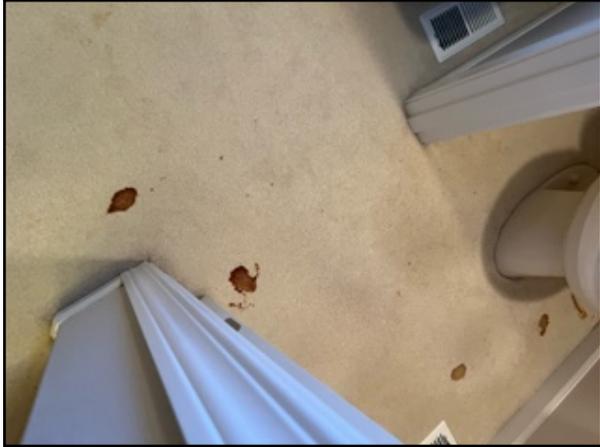
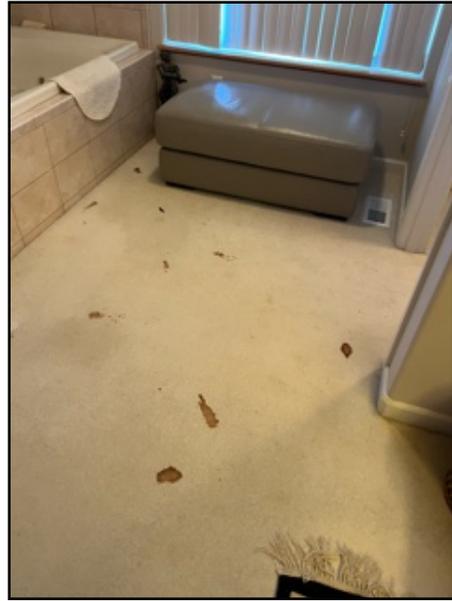
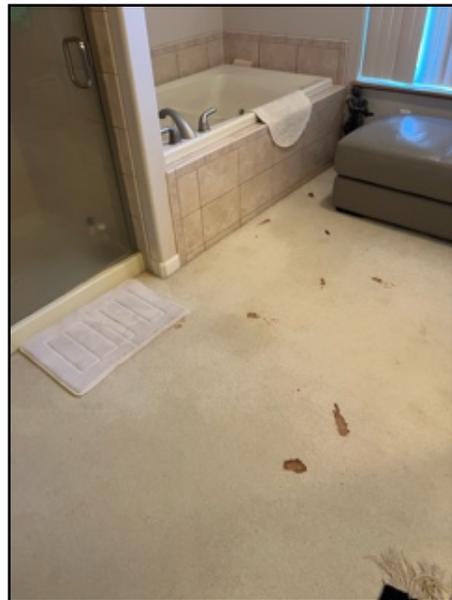
Carpet in upstairs bedroom stained (pet remains). Recommend a qualified contractor assess and replace carpet.
