AK Home Inspection Services LLC

Home Inspection Report

14012 E River Bend Cir

Inspected on Mon, Jun 24 2024 at 10:00AM

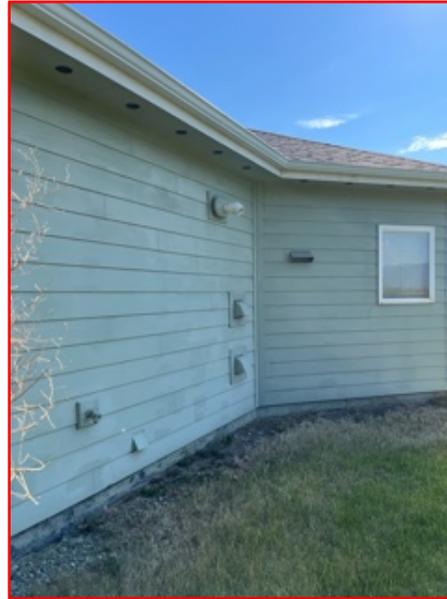
Figure 1-2

Paint wearing/thin spots on the southern back side of the house. Recommend sanding and painting the exterior of the house to extend the life of the siding.

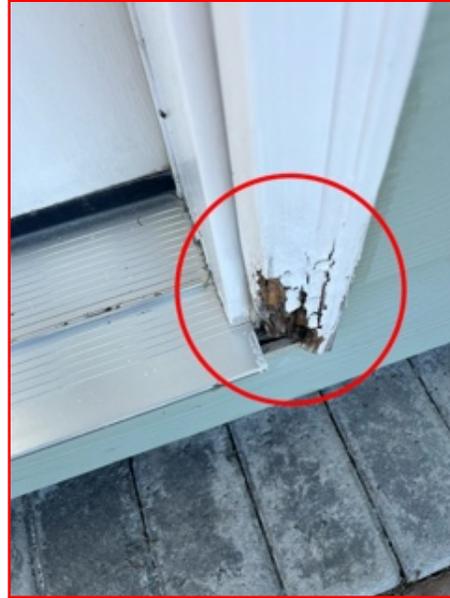
Figure 2-2

Back exterior door jamb has water damage at the bottom of the door jam possibly from snow melt water runoff. Recommend a qualified contractor assess and see if the jam needs to be replaced or just sanded and painted.

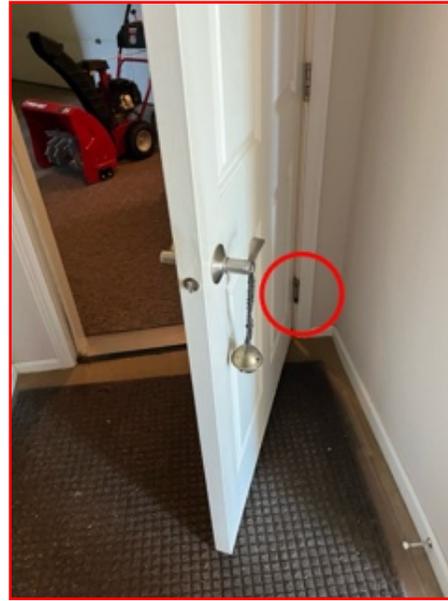
Figure 3-2

Both garage entry doors into living areas are fire safety doors. They have to close and latch on their own and make an air tight seal. Recommend a qualified contractor adjust or replace the spring hinges to allow the doors to close and latch on their own and new gaskets if necessary to seal properly.

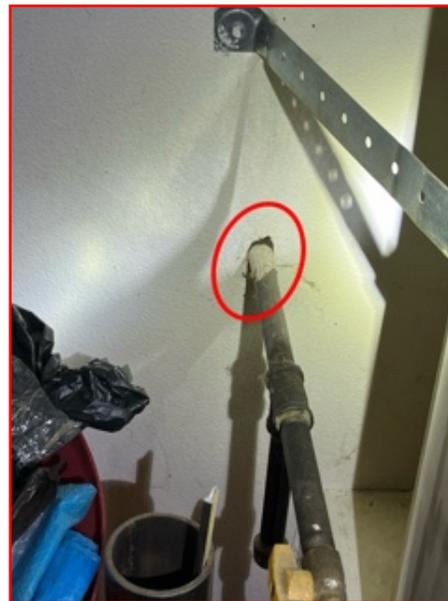
Figure 4-2

Multiple penetrations through the Sheetrock in the garage are not fire caulked. All penetrations through Sheetrock from garage need to be fire caulked to keep fumes from entering the home. Recommend fire caulking all penetrations through the ceiling and walls in the garage.

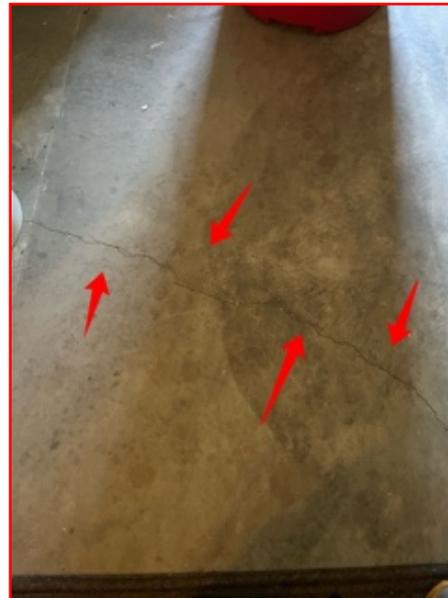
Figure 5-2

It was observed that there are cracks (1/16"-1/8") in the garage concrete slab. Recommend a qualified contractor assess and seal with epoxy to fill, strengthen, and waterproof the slab.

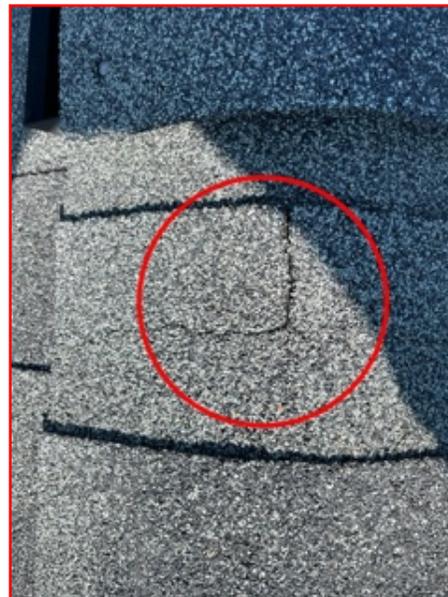
Figure 6-2

Several missing shingles, exposed wood sheathing, a few torn shingles to fiberglass layer, and rusted nail heads visible. Roof is believed to be the original roof (16 yrs old). Recommend a qualified roofing contractor assess and fix/repair missing shingles, torn shingles and epoxy nail hairs to weatherproof.

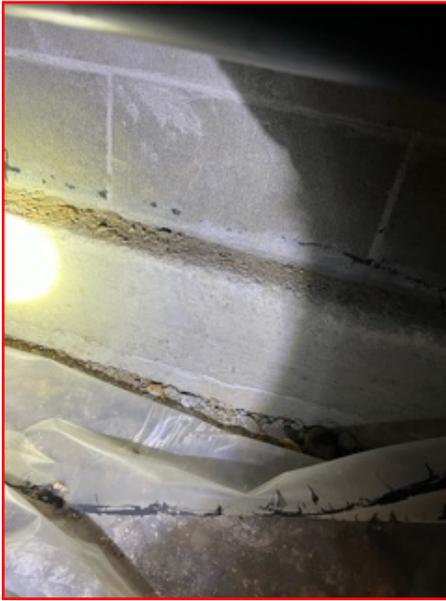
Figure 7-3

Vapor retarder is in place, but starting to come away from the acoustic caulking on some spots on the concrete footer. Recommend having a contractor re-seal the vapor barrier to the walls and footer properly with acoustic caulking.

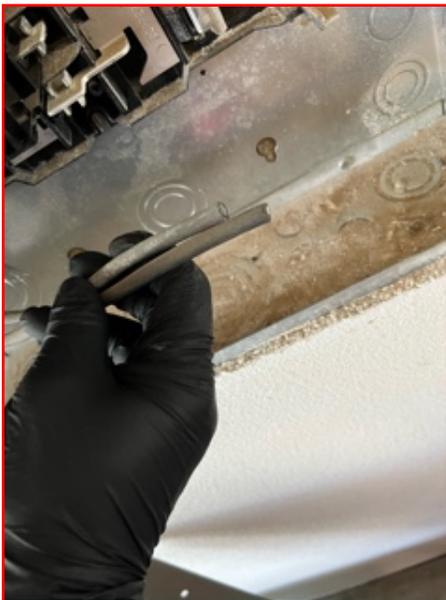
Figure 8-3

The distribution service panel in the garage has possible multi branch wiring. Also, 2 large (6 gauge) wires exposed in the box. Recommend a qualified electrician assess and fix/repair with handle tying the breakers so one can't trip without the other or install black tape on the red wires to signal a 120 conductor and terminate large gauge wires with wire nuts.

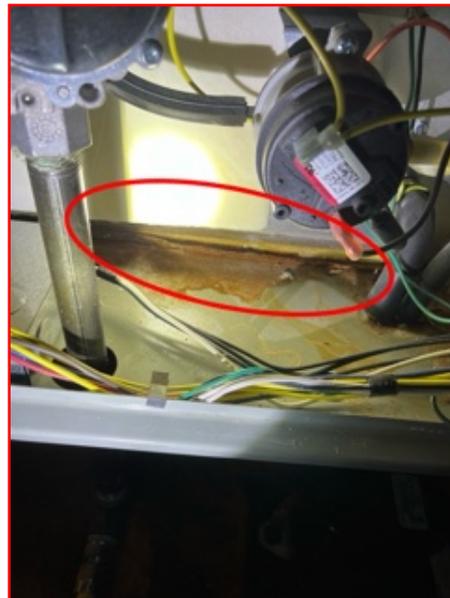
Figure 10-2

No recent records of service for furnace, water heater, or garage unit heater. Also, found rust in the burner area. Recommend a qualified contractor to service, clean, and inspect furnace, water heater, and garage unit heater with filter replacement on the furnace.

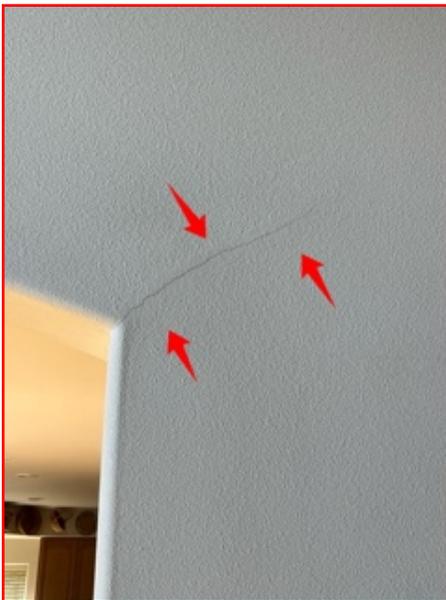
Figure 12-3

It was observed that there was some foundational movement that occurred with horizontal, vertical, and diagonal cracking above doors and windows. Windows and doors still open and close so, it appears to be mostly superficial Sheetrock cracking. Recommend a qualified contractor assess and fix/repair Sheetrock.

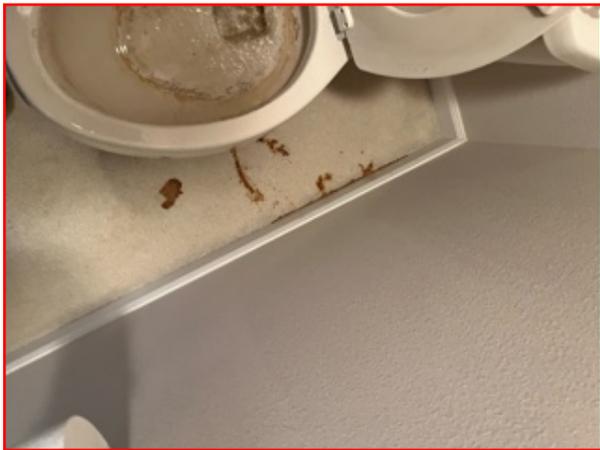
Figure 14-3

Carpet in upstairs bedroom stained (pet remains). Recommend a qualified contractor assess and replace carpet.

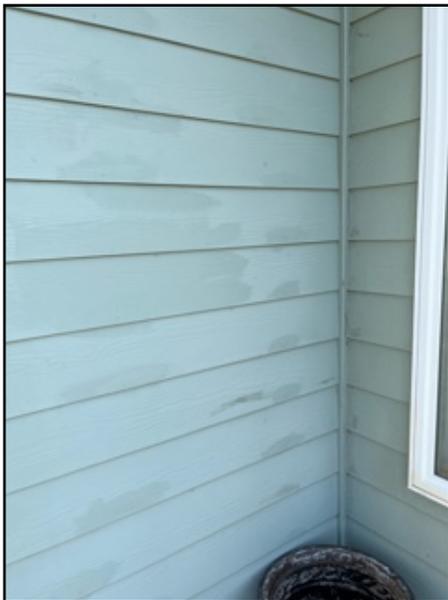
Figure 1-3

Paint wearing/thin spots on the southern back side of the house. Recommend sanding and painting the exterior of the house to extend the life of the siding.

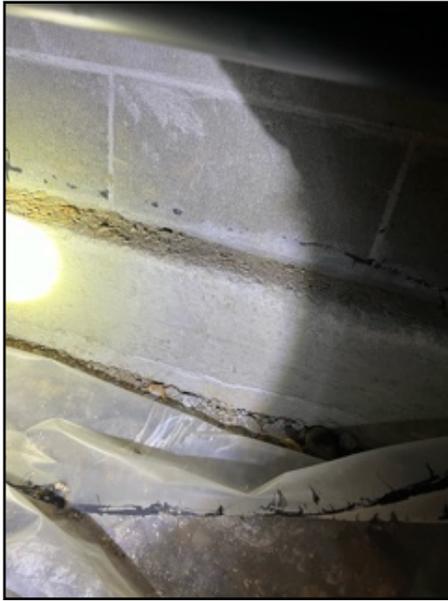
Figure 7-3

Vapor retarder is in place, but starting to come away from the acoustic caulking on some spots on the concrete footer. Recommend having a contractor re-seal the vapor barrier to the walls and footer properly with acoustic caulking.

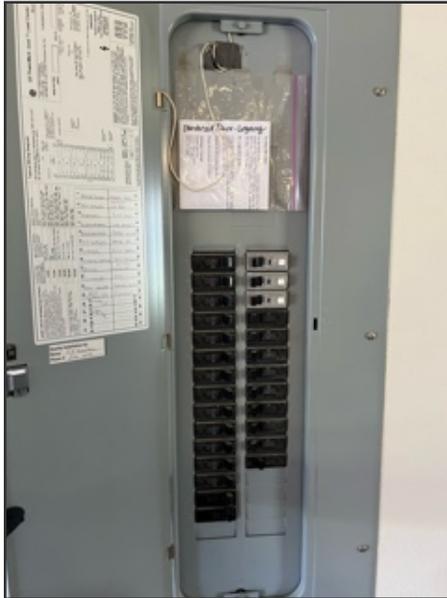
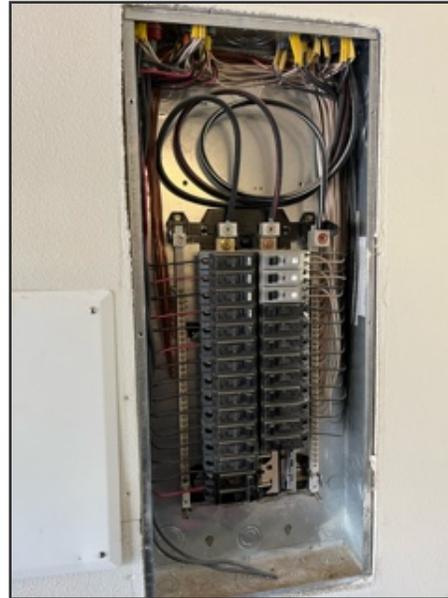
The distribution service panel in the garage has possible multi branch wiring. Also, 2 large (6 gauge) wires exposed in the box. Recommend a qualified electrician assess and fix/repair with handle tying the breakers so one can't trip without the other or install black tape on the red wires to signal a 120 conductor and terminate large gauge wires with wire nuts.

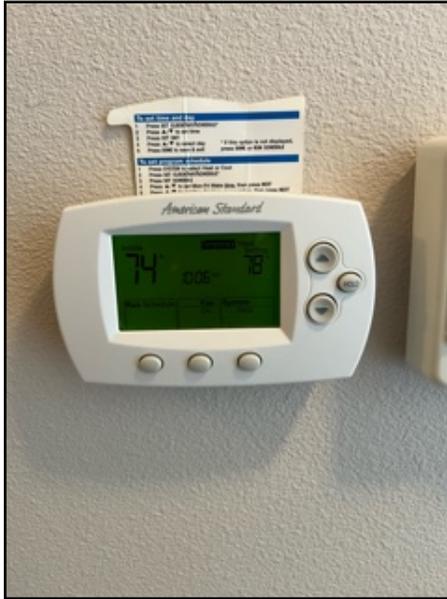
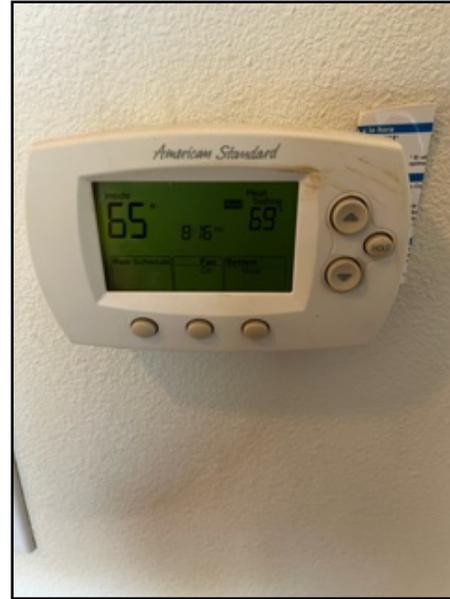
No recent records of service for furnace, water heater, or garage unit heater. Also, found rust in the burner area. Recommend a qualified contractor to service, clean, and inspect furnace, water heater, and garage unit heater with filter replacement on the furnace.

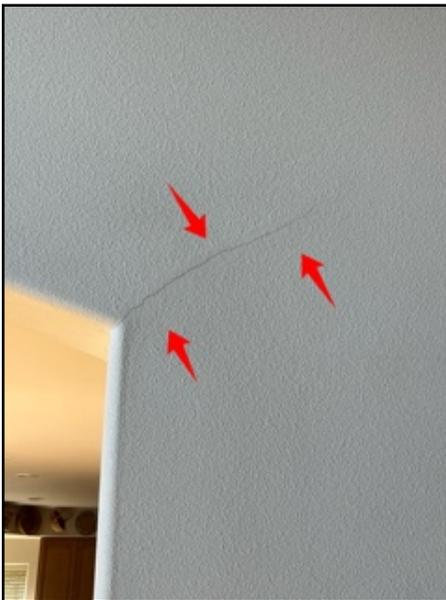
Figure 12-3

It was observed that there was some foundational movement that occurred with horizontal, vertical, and diagonal cracking above doors and windows. Windows and doors still open and close so, it appears to be mostly superficial Sheetrock cracking. Recommend a qualified contractor assess and fix/repair Sheetrock.

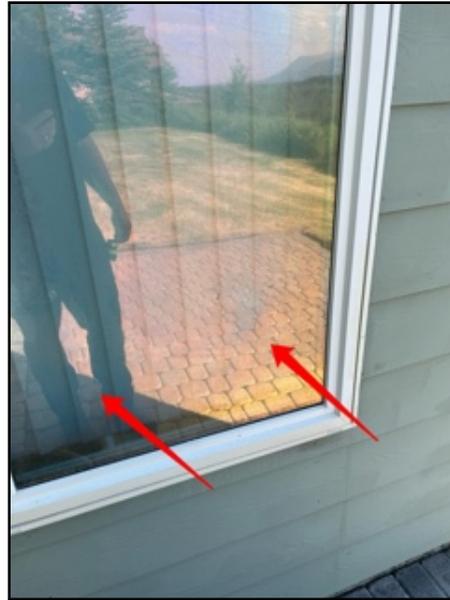
Figure 13-2

Living room window is fogged and the seal has broken letting moisture in between the panels of glass. Recommend a qualified contractor fix/repair or replace the window.

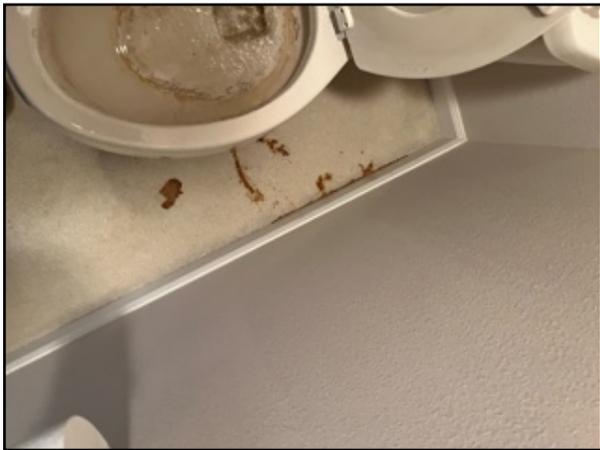
Figure 14-3

Carpet in upstairs bedroom stained (pet remains). Recommend a qualified contractor assess and replace carpet.
