FORMAL PROJECT APPROVAL

Name of Project: Fine Arts Complex Vapor Barrier
Project Type: DM and R&R
Location of Project: UAF, Fairbanks Campus, Fine Arts Building Music Wing FS312, Fairbanks
Project Number: 2012045
Date of Request: August 21, 2012

Project: Fine Arts Music Wing Vapor Barrier & Wall Analysis - Phase 2

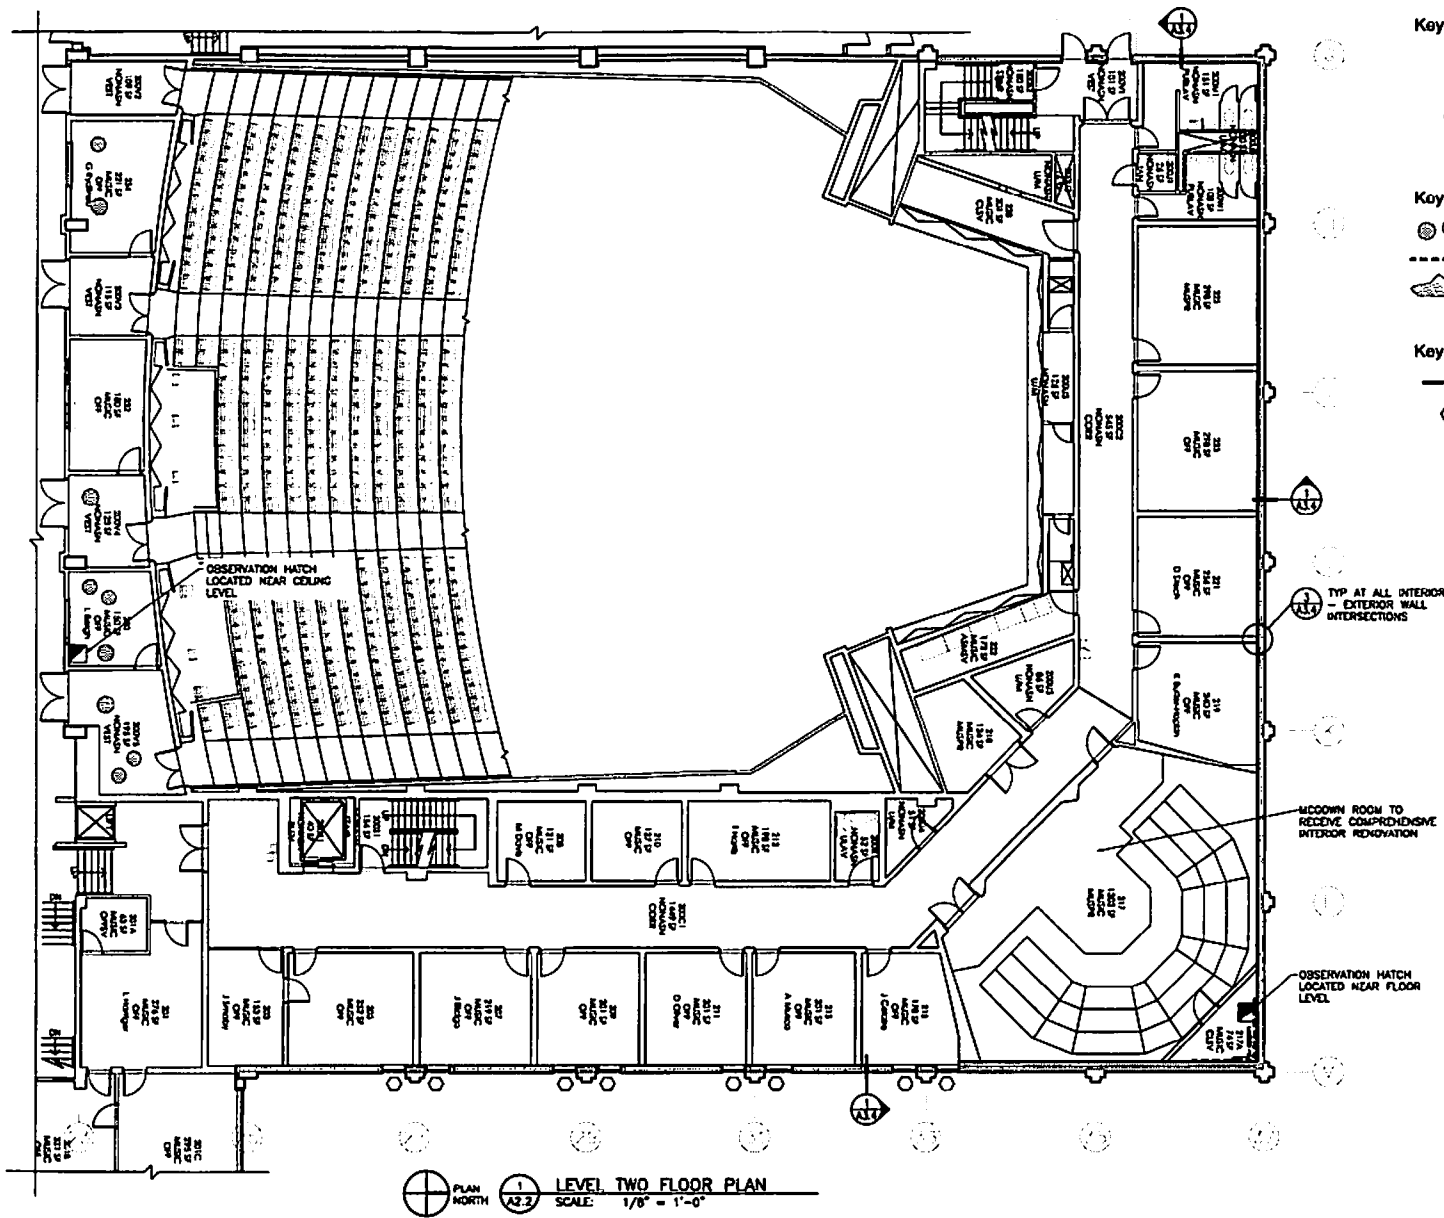
Sheet No.: A2.2

Key to Wall Cavity Observation Points

- Access hatch installed 2010
- Access hatch installed 2011
- Test hole out 2012

Key to Observed Moisture Problems

- Location of Ceiling Drips
- Location of Severe Condensation at Walls
- Flooding Locations on Floor

Key to Retrofit Recommendations

- Interior Wall Retrofit Locations
- Window to be Relocated to Thermal Plane

Sheet Contents: LEVEL TWO FLOOR PLAN

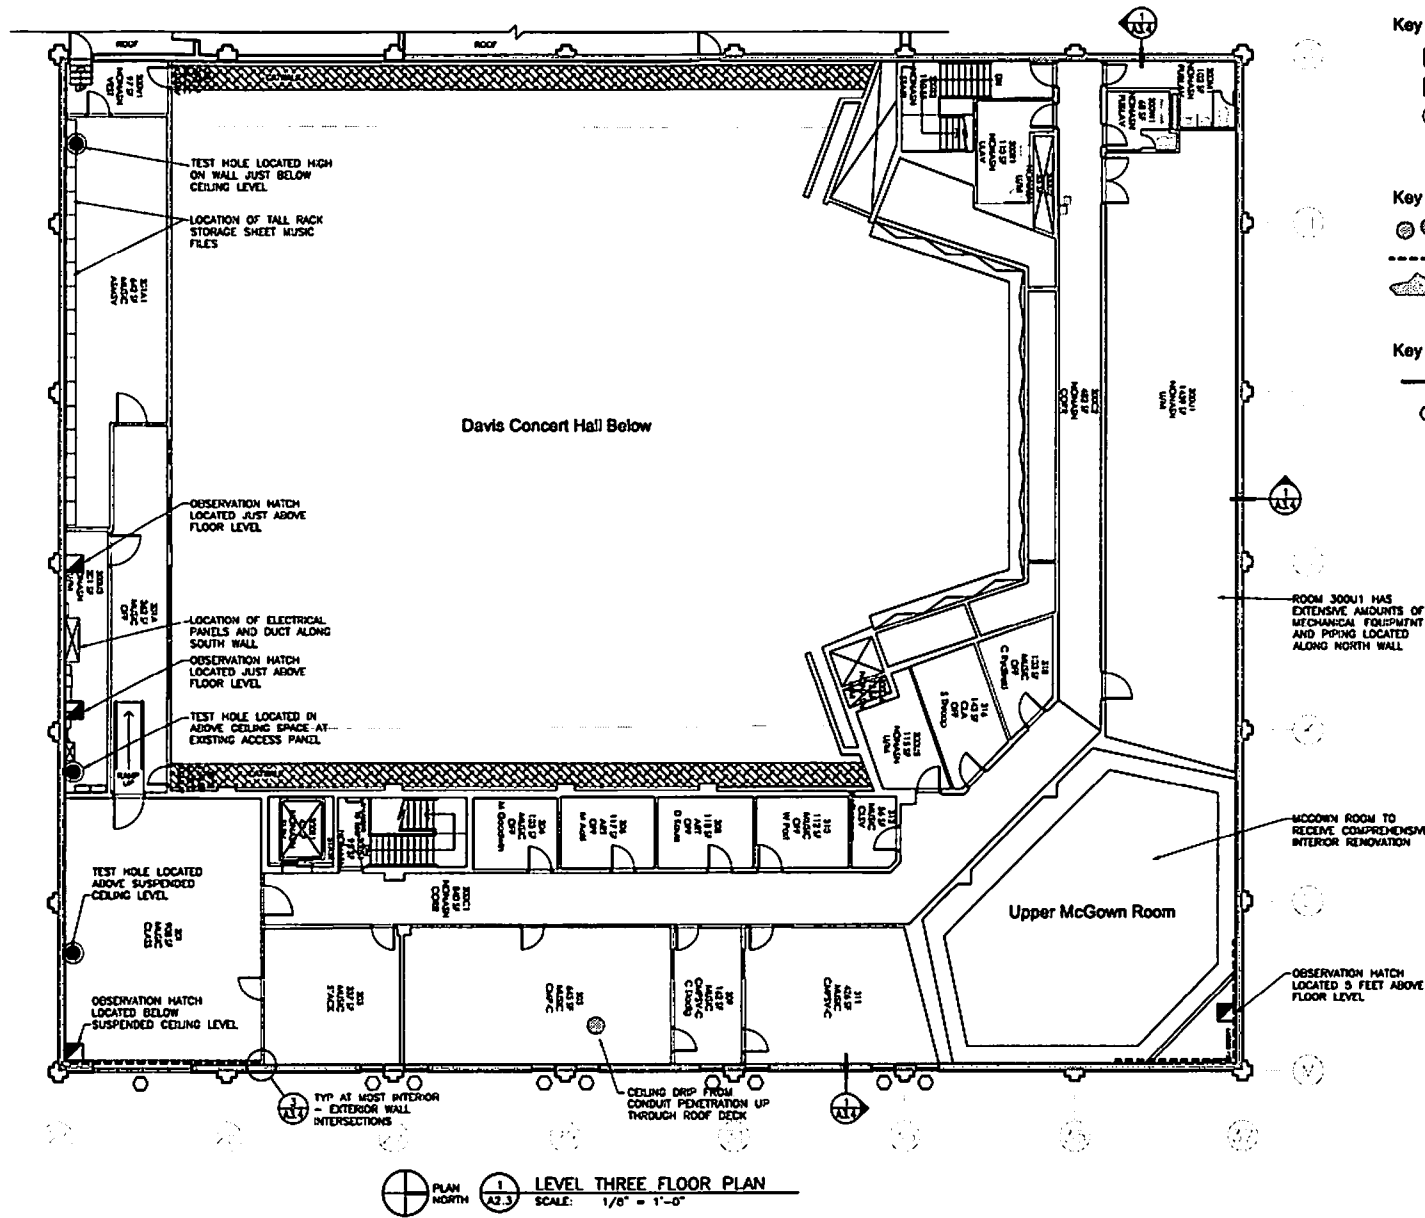
Sheet No.:
A2.3

Key to Wall Cavity Observation Points

- Access hatch installed 2010
- Access hatch installed 2011
- Test hole cut 2012

Key to Observed Moisture Problems

- Location of Ceiling Drips
- Location of Severe Condensation at Walls
- ▲ Flooding Locations on Floors

Key to Retrofit Recommendations

- Interior Wall Retrofit Locations
- Window to be Relocated to Thermal Plane

Sheet Contents:
LEVEL THREE FLOOR PLAN

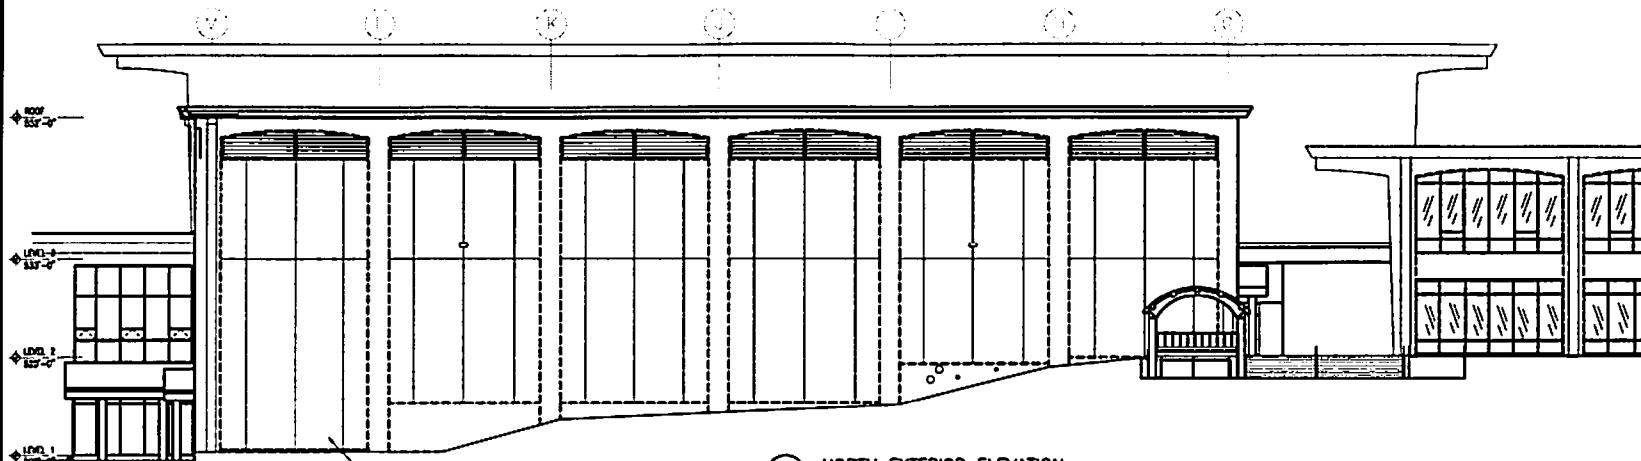
1 NORTH EXTERIOR ELEVATION
SCALE: 1/8" = 1'-0"

PRACTICE ROOM 129 BEYOND,
SUSPECTED GROUND WATER
INTRUSION AT FOUNDATION

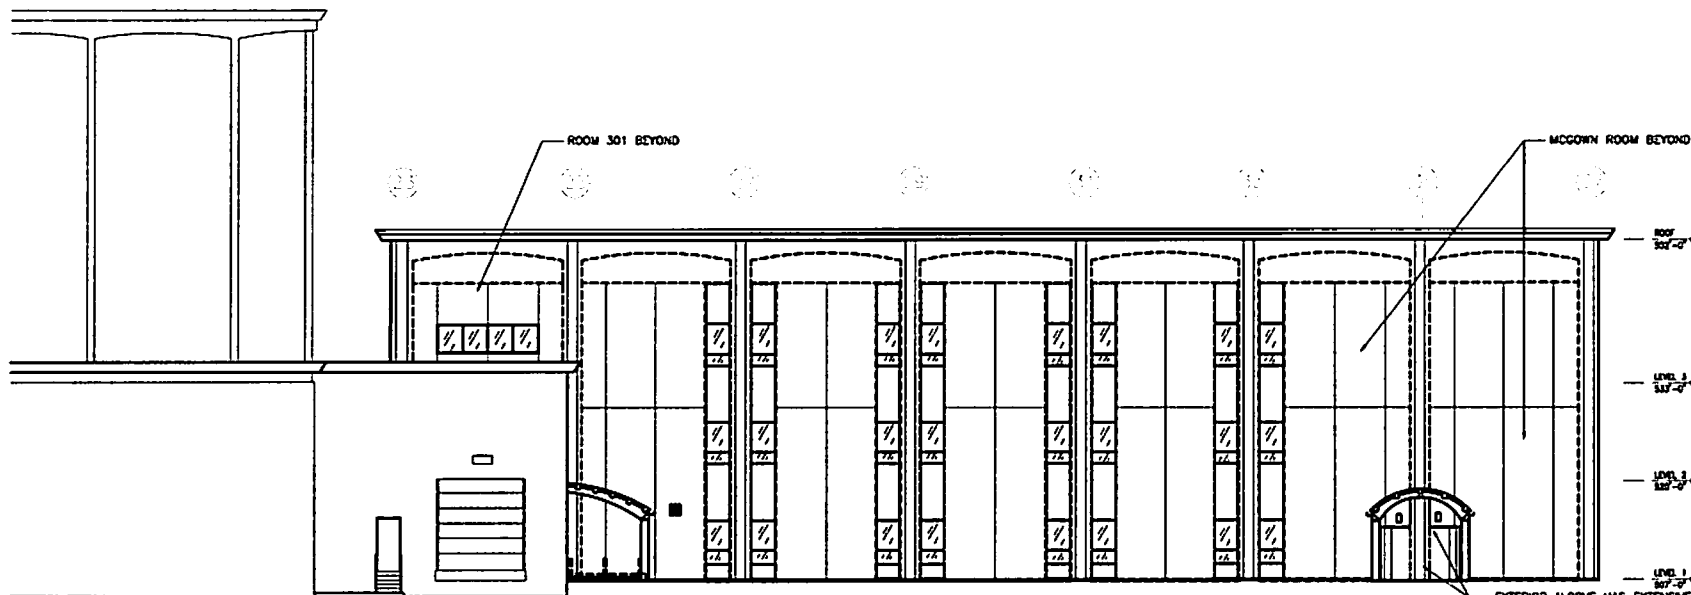
2 EAST EXTERIOR ELEVATION
SCALE: 1/8" = 1'-0"

EXTERIOR ALCOVE HAS EXTENSIVE
MOISTURE DAMAGE AT SOFFIT AND
WALLS

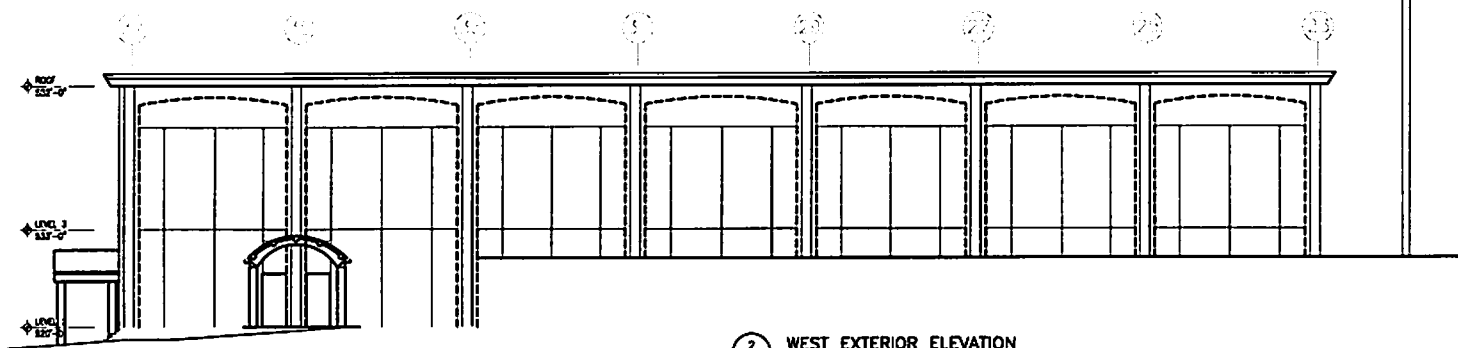
2 WEST EXTERIOR ELEVATION
A3.2 SCALE: 1/8" = 1'-0"

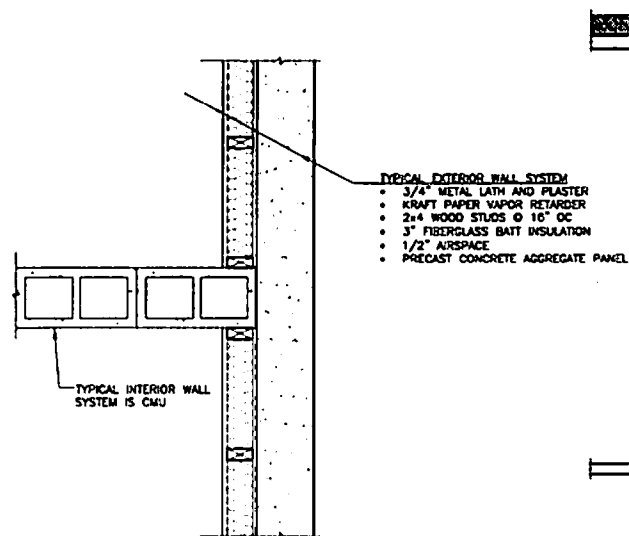
3 TYPICAL INTERIOR-EXTERIOR WALL INTERSECTION
SCALE: 1 1/2" = 1'-0"

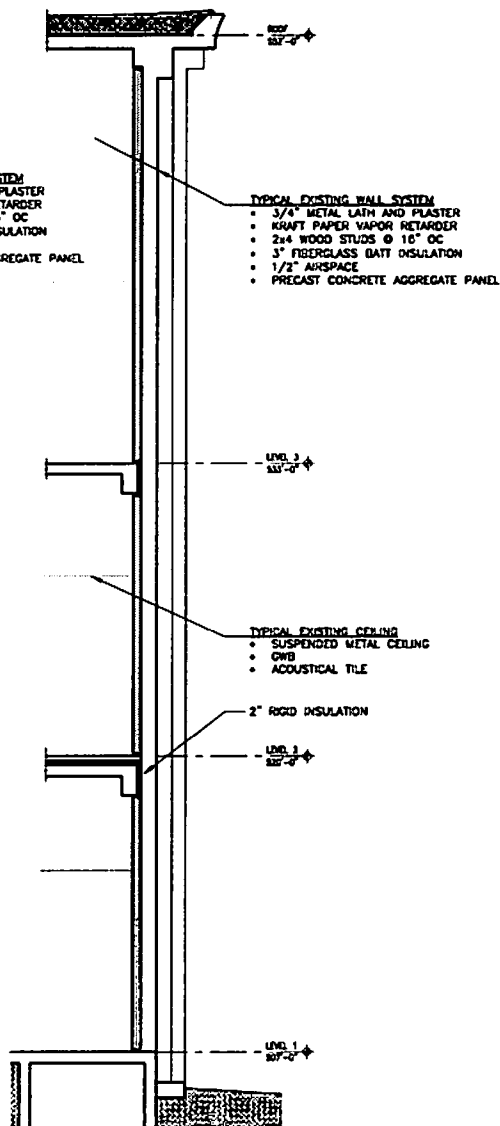
1 TYPICAL EXISTING WALL SECTION
SCALE: 3/8" = 1'-0"

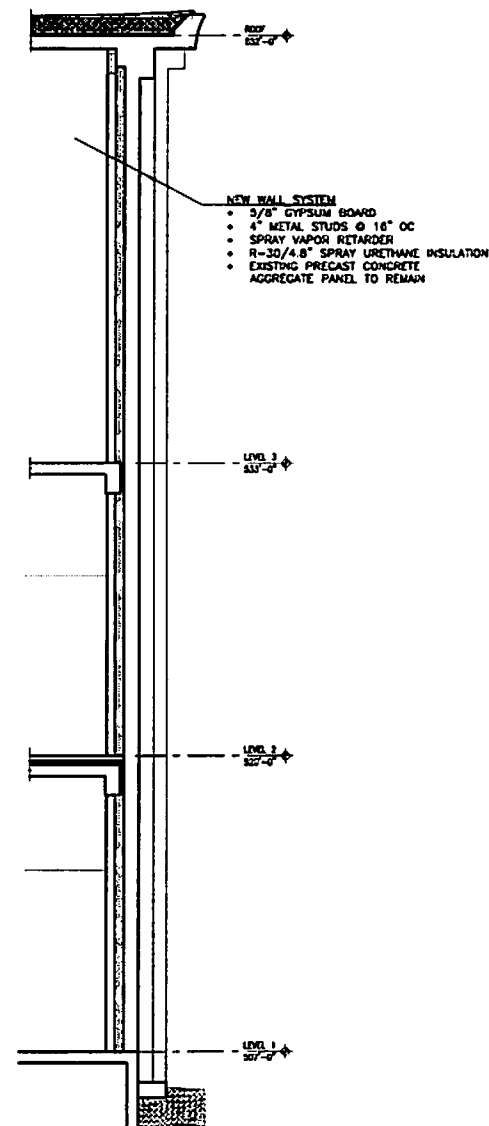
2 TYPICAL RETROFIT WALL SECTION
SCALE: 3/8" = 1'-0"

This project will correct Music Wing building envelope deficiencies by retrofitting the interior walls with spray foam and other treatments that will increase the R value over the existing condition and simultaneously create a vapor barrier. The retrofit process will include the removal of all materials up to the inside of the exterior concrete tip up panels.
