## TIRE CHAIN DAMAGE ON BRIDGE DECK WEARING SURFACES

### Summary

## **1. Introduction**

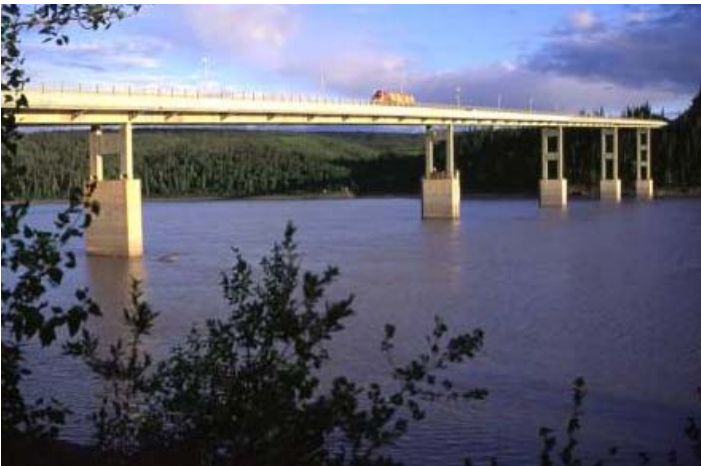
Figure 1. Yukon River Bridge

The Yukon River Bridge is a 2-lane highway bridge with a width of 9.2 m. The structure is located about 50 miles North of Fairbanks on the Dalton Highway. The structure was designed to carry highway traffic, the oil pipeline and a future gas line. The superstructure consists of two closed steel box girders that support an orthotropic steel deck. The structure was built in the early 70's and at the time, a 127-mm two-layer a temporary timber wearing surface was placed over the steel deck. The bridge has 6 spans and it is on a 6% grade, see Figures 1 and 2 [1, 2, 3]; Because of the steep grade, trucks typically use chains and this has caused several problems. Chains tend to plane the timber deck causing loss of section and reduced traction with time. Subsequently, timber deteriorates rapidly under the severe climate and loads.

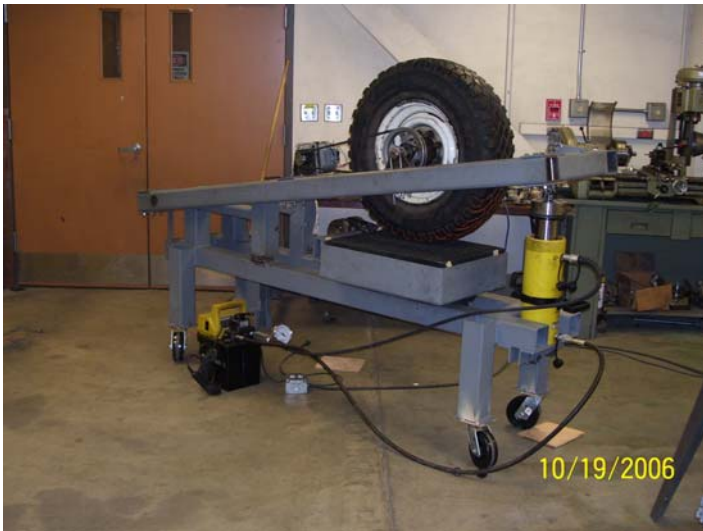
Figure 3. Traction Equipment

Tire chains on heavy trucks are considered to be a major source of damage to the bridge deck wearing surface. Since no known laboratory test could be found to determine wear due to tire chains, test equipment and a testing procedure was developed. The testing apparatus consists of a tray which contains the sample to be tested; this tray maybe moved horizontally over a distance of 20 cm by use of a hydraulic ram. Located over the sample tray is a 14 ply 235/85R16 tire through which down ward force many be applied to the sample by means of a second hydraulic ram. The tire is located on an axle and that may be allowed to rotate in the direction of motion of the sample, or locked depending on the requirements of a given test. Electric load cells are provided to measure vertical and horizontal force on the tire in the direction of motion of the sample. Test samples maybe up to 45 cm wide by 61 cm long by 15 cm thick. The entire apparatus is approximately 60 cm wide 230 cm long and weighs around 4500 N. The small size is required to fit within the low temperature testing room available, see Figure 3.

Since it is near impossible to conduct a test featuring all three of these actions in a small area in a laboratory setting, they were tested and analyzed separately. Impact damage was measured by rotating a tire with chains over the sample. The speed of rotation was equivalent to a vehicle moving at 65 kph. Links of chain were allowed to impact the surface for several seconds. The amount of material removed was measured by profiling the surface before and after the test.

Rolling damage was tested by placing a tire with chains on the test sample. A vertical load was applied to the wheel that was equivalent to the force of a standard axle load of 80 kN (18,000 lbs). The tire was free to rotate as the test sample was moved under the tire for a given number of cycles. Depth of indentation formed by the chains was measured.

Slipping or dragging damage caused by tire chains was measured by placing a vertical load on the wheel which imposed load to the test sample. This was similar to the rolling test. However, in this case, the wheel was prevented from rotating while that sample was moved under the tire and chain. This test was developed to measure damage caused by drag between a tire chain and the wearing surface. The amount of material removed was measured by profiling the surface before and after the test.

In addition to tests for surface damage, samples were also tested for traction. This was done by loading the tire, without chains but with rotation of the tire prevented. A vertical load was applied to the wheel. With the vertical load acting on the wheel, the force required to move the sample was measured (this was the friction force). Normal force was measured indirectly and friction force was measured directly. The coefficient of friction was then calculated. Traction tests are in progress for varying surface conditions, including: dry, wet, lightly ice covered, and with snow packed into the surface to the top of the surface texture.
